Issue # 364

December 27, 2016

Internally Galvanized Steel Pipe Blamed for Explosions

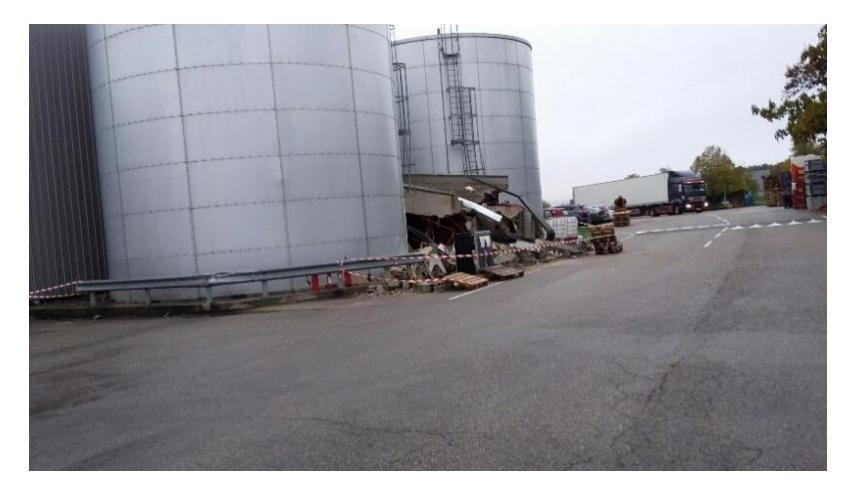
The most recent explosion destroyed a pump house in France in late October, after a sprinkler contractor drained a sprinkler system to allow some work to be performed on the system. The control valves for the system were located within the pump house, and the explosion reportedly took place about 15 minutes after the drain valve was opened, the system left unattended and draining. Although the pump house was destroyed, no one was injured. The diesel engine and fuel tank were originally suspected to somehow be the source of the explosion. Later, however, parallels were found to two explosions that had taken place in 2014 in Denmark, both of which took place in sprinkler piping following drainage of water from the systems, and both of which resulted in injuries to maintenance personnel.

The pump house destroyed in the October 2016 explosion.

The Confederation of Fire Protection Associations-Europe reports that a technical investigation funded by Finance Norway led to the conclusion that water within the systems had reacted with the internal zinc linings of the piping to

produce hydrogen gas. Random sparks ignited the gases as they were released during draining of the systems.

- Be on the lookout for abnormal pressure increases within the systems
- Ensure good ventilation as the systems are being drained
- Avoid doing work in the areas while systems are being drained
- If work must be performed in areas where systems are being drained, use only non-sparking tools
- Consider the use of gas detectors or explosimeters to monitor for hydrogen gas levels
